Manhole Inspection Summary

Manhole # S49Y1_007MH

Insp Date: **4/14/09 1:51 PM**

Location Address: **1500 Chesapeake Ave.**

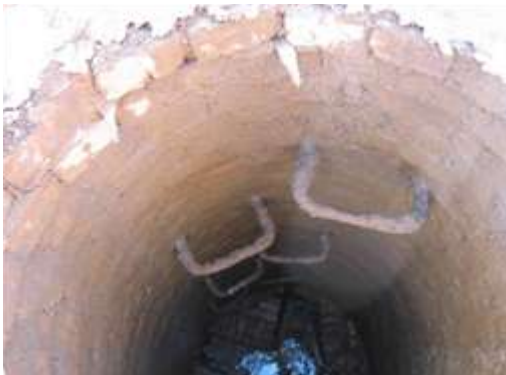
steps

Count: **9** Missing: **1** ☒ **Corroded**

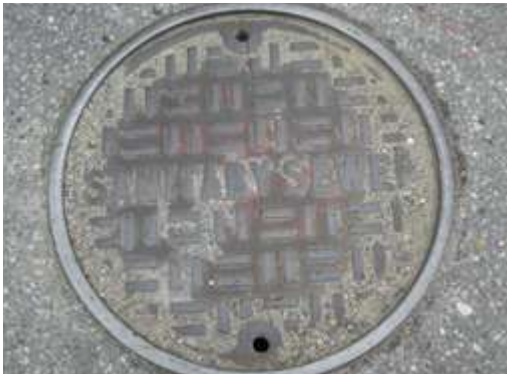
Cover

Condition: **Cracked**

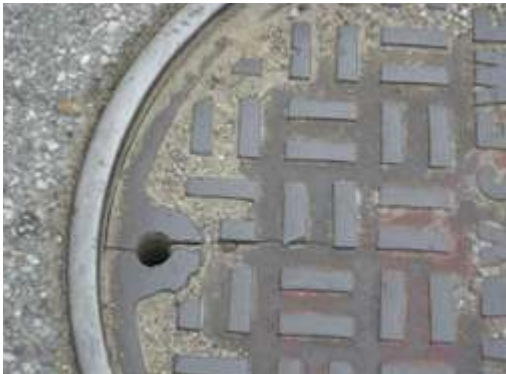
Defect 1

Cracked Cover

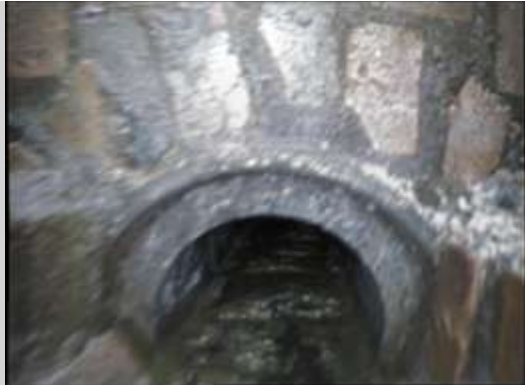
12 O'Clock Outflow

8 in. Circular Gravity Sewer
Pipe Out @ 12 O'Clock

Pipe Height: **9.6** (in.) Rod and Bar (Angled)
Pipe Material: **Clay** ☐ Pipe Lined
Invert Depth: **13.50** (ft.) Flow Characteristics: **Slow**
Deposits: ☒ None ☐ Mud ☐ Sludge ☐ Debris ☐ Grease
Silt Depth: (in.) Deposits Extent:
Infiltration: **None** Pipe Seal Cond: **Sound**

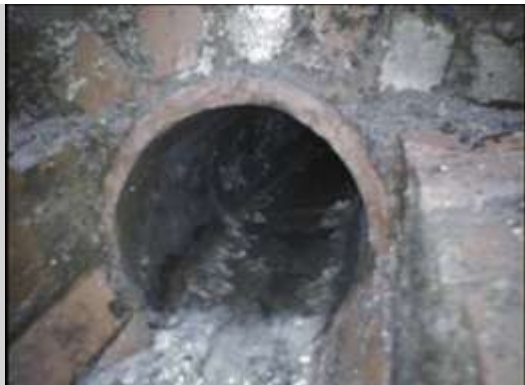
3 O'Clock Inflow

8 in. Circular Gravity Sewer
Pipe In @ 3 O'Clock

Pipe Height: **10.8** (in.) Rod and Bar (Angled)
Pipe Material: **Clay** ☐ Pipe Lined
Invert Depth: **13.20** (ft.) Flow Characteristics: **Slow**
Deposits: ☒ None ☐ Mud ☐ Sludge ☐ Debris ☐ Grease
Silt Depth: (in.) Deposits Extent:
Infiltration: **None** Pipe Seal Cond: **Sound**

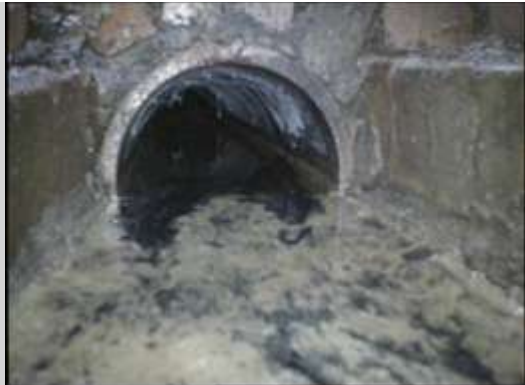
6 O'Clock Inflow

8 in. Circular Gravity Sewer

Pipe In @ 6 O'Clock

Pipe Height: **10.8** (in.) Rod and Bar (Angled)

Infiltration: **None** Pipe Seal Cond: **Sound**

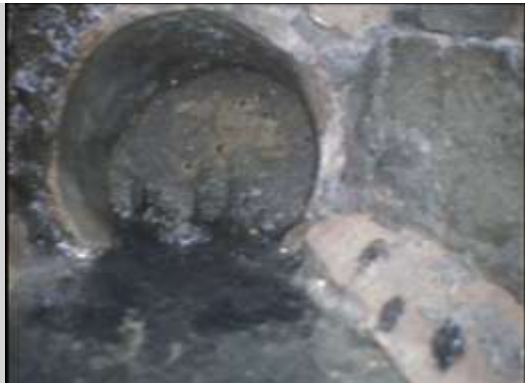
9 O'Clock Inflow

8 in. Circular Gravity Sewer

Pipe In @ 9 O'Clock

Pipe Height: **9.6** (in.) Rod and Bar (Angled)

Infiltration: **None** Pipe Seal Cond: **Sound**

Connects To: **Stub connection / abandoned**
